**Gibraltar Harbour
Site Survey and Installation
Of a Radar Tide Gauge**

July 2006

Proudman Oceanographic Laboratory

Internal Document No. 179

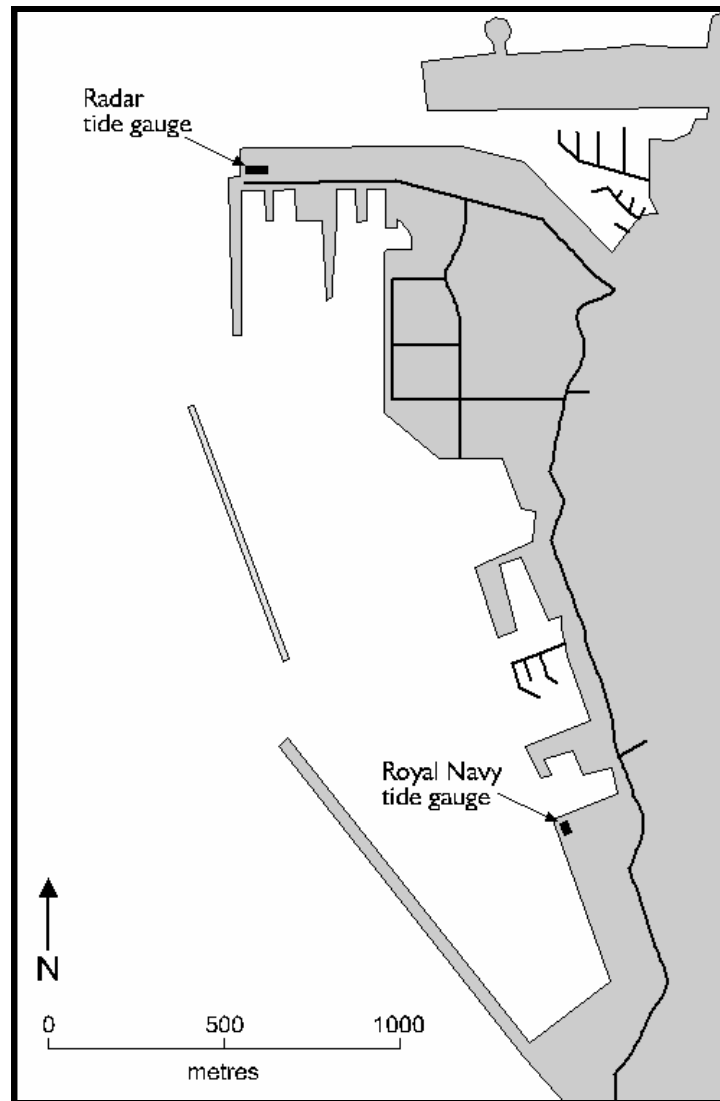
The Tide Gauge Inspectorate, TGI visited Gibraltar on 7th May 2003 for a meeting with Captain J Ferro, Captain of the Port. During the discussion it became clear that the Captain was responsible for the commercial part of the port and that the existing tide gauge is sited about 2 kilometres away in the Royal Naval Base (fig 1).

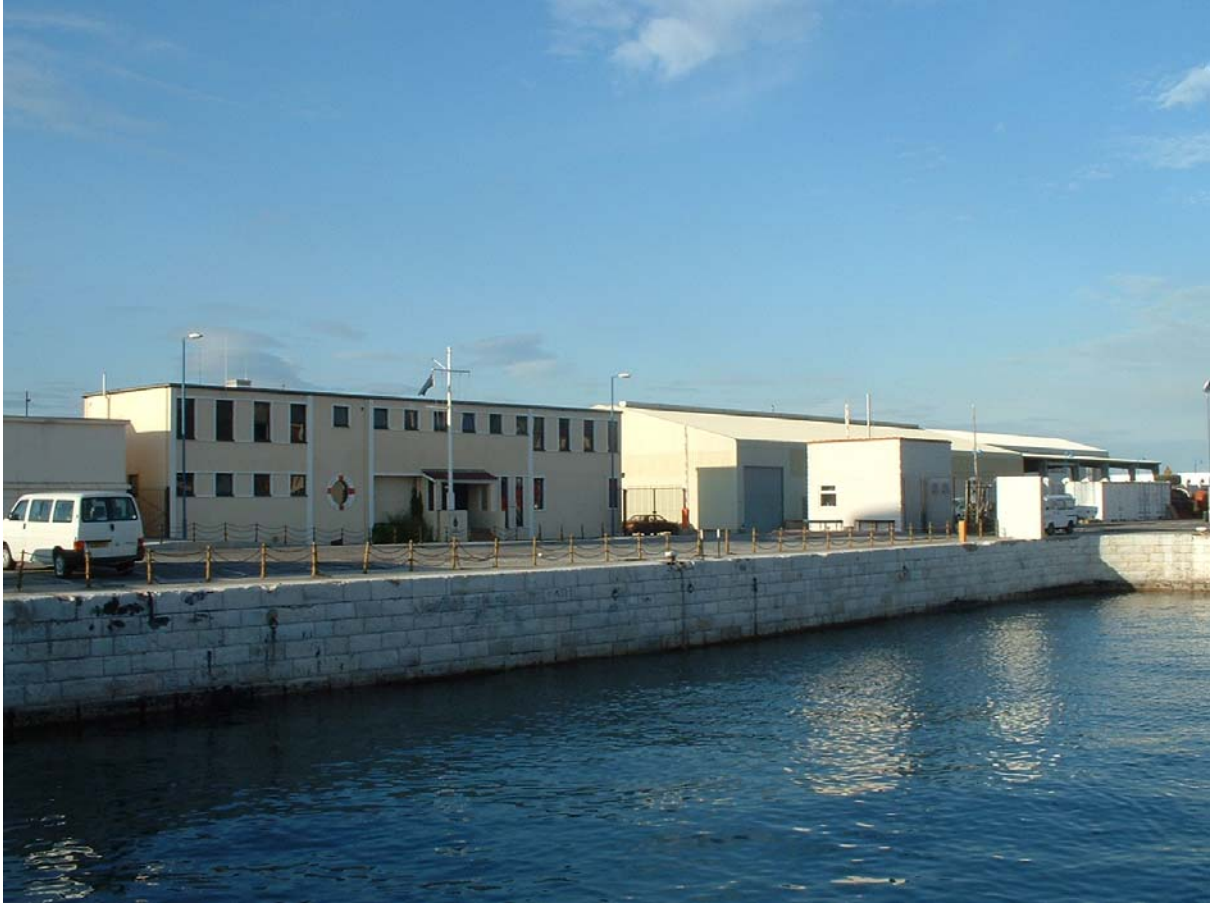
Port Authority offices and tide gauge site

There were two possible systems that could be installed at the site, a pneumatic bubbler or a radar gauge. It was agreed at the meeting that the radar gauge was the most suitable instrument and that there were a number of possible sites where the gauge could be installed. A survey of the commercial port was completed and a site identified on the quay in the North East corner of the pilot boat basin.

The port security lodge is close by with an electricity supply and telephone line. It was also agreed that a room in the lodge could be used to house the data logging system. The Port Control in the Harbour Office is 50 metres away from the security lodge. The port requested that a digital display and an output to a PC were included in the specification.

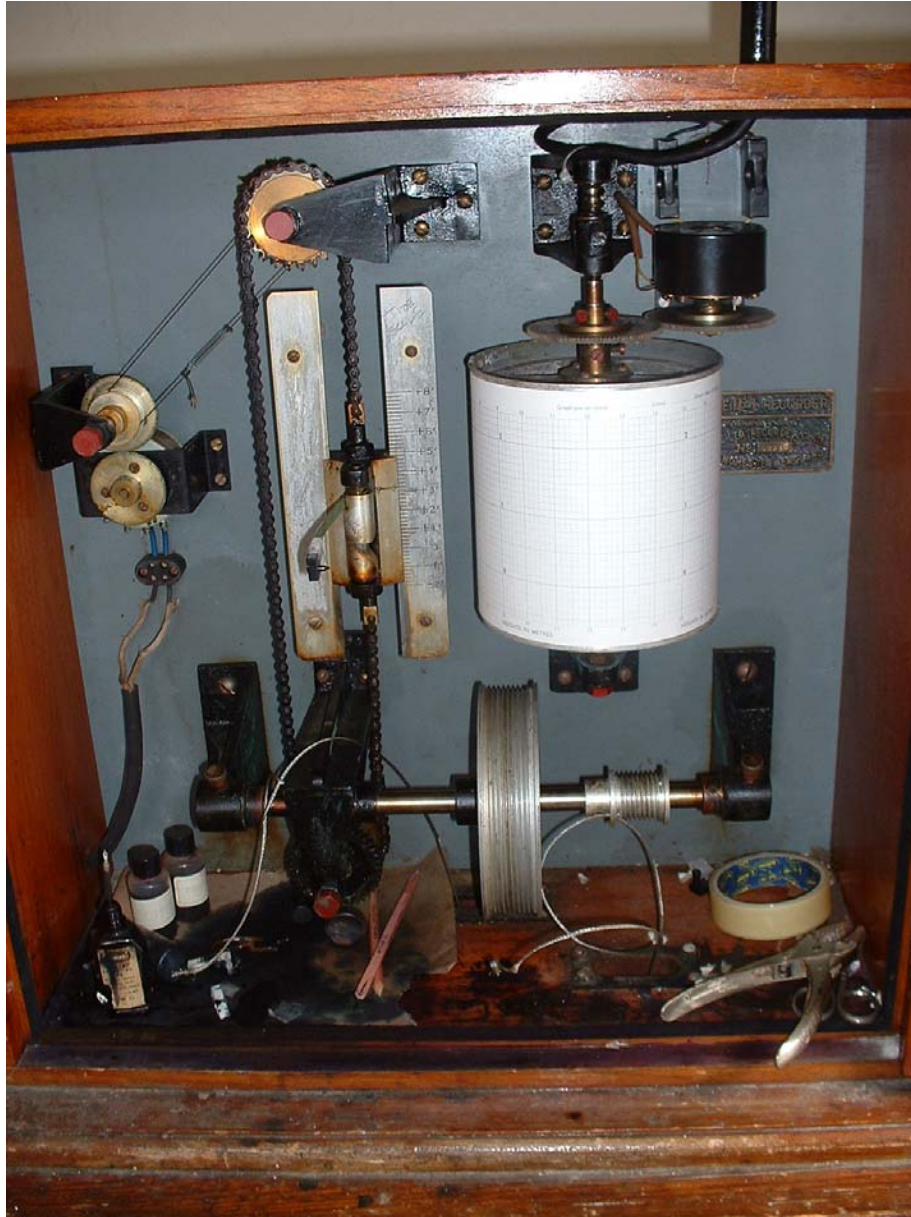
Royal Naval base Lea Gauge

The Captain of the Port arranged a meeting with the Queens Harbour Master, QHM of the Royal Naval Base. The QHM had been in post for about 3 months, during that time the tide gauge had not been operational. The TGI inspected the gauge, a float operated analogue recorder manufactured by Lea in 1960. The gauge was not operational, both the float and counterweight wires were tangled and the gauge was jammed.

With the help of the QHM the wires were removed and refitted. The person responsible for the tide gauge was away on leave and equipment wasn't available to accurately set the gauge on datum. The visual tide staff was also missing, so the QHM estimated the sea level and the gauge was set to that height. The TGI gave the QHM instructions on how to set the gauge on datum.

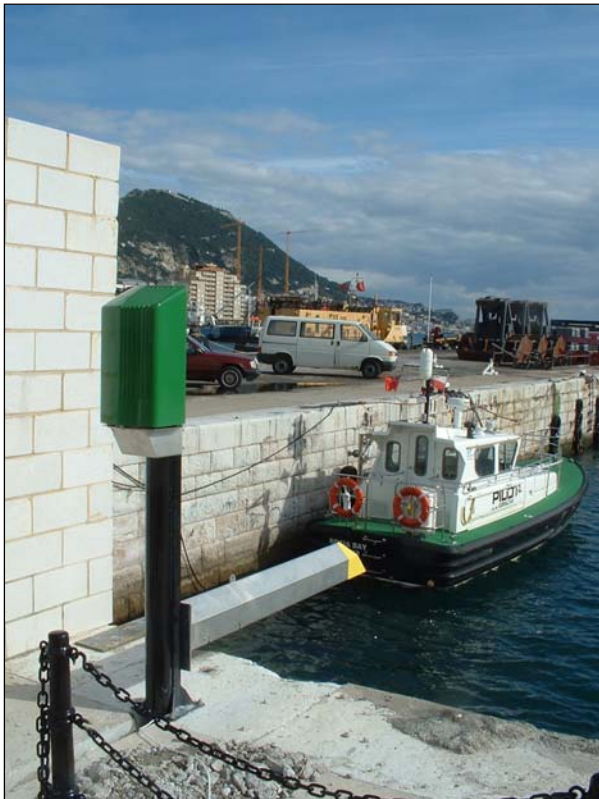
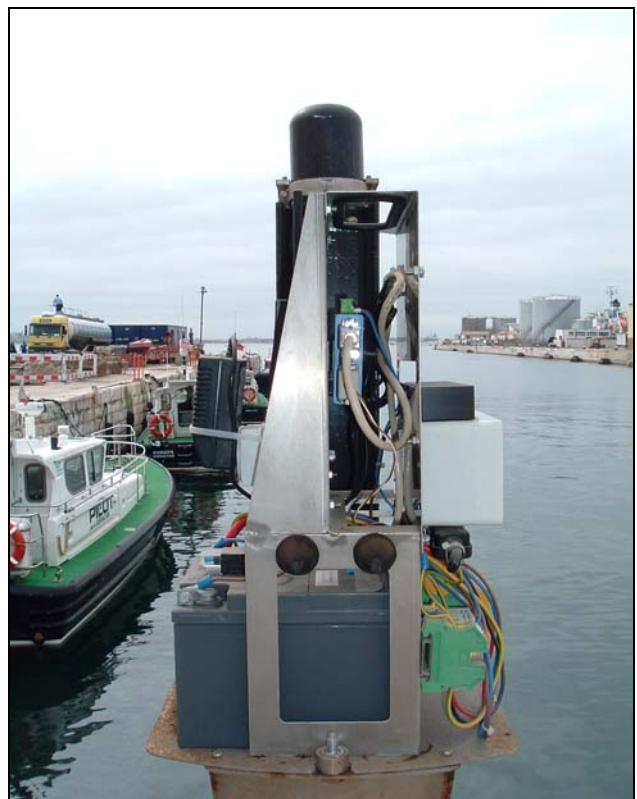
Radar gauge and housing layout

Dave Smith and Les Bradley from the TGI together with Simon Holgate PSMSL visited Gibraltar in April 2004 to install the tide gauge system. An electrical contractor had cut a trench between the security lodge and the tide gauge. A duct and cable were laid providing a 110 volt supply. The radar gauge stanchion was bolted to the quay and adjusted so that the stanchion was vertical. The Kalesto radar head was mounted horizontally protected by a stainless steel cover with a 45° end plate to deflect the radar beam down to the sea surface. A weather proof housing was attached to the radar gauge stanchion. The housing contains a power control unit, signal converter, back-up battery and RS232 radio transmitter. The data is transmitted to the Port office some 50 metres from the gauge

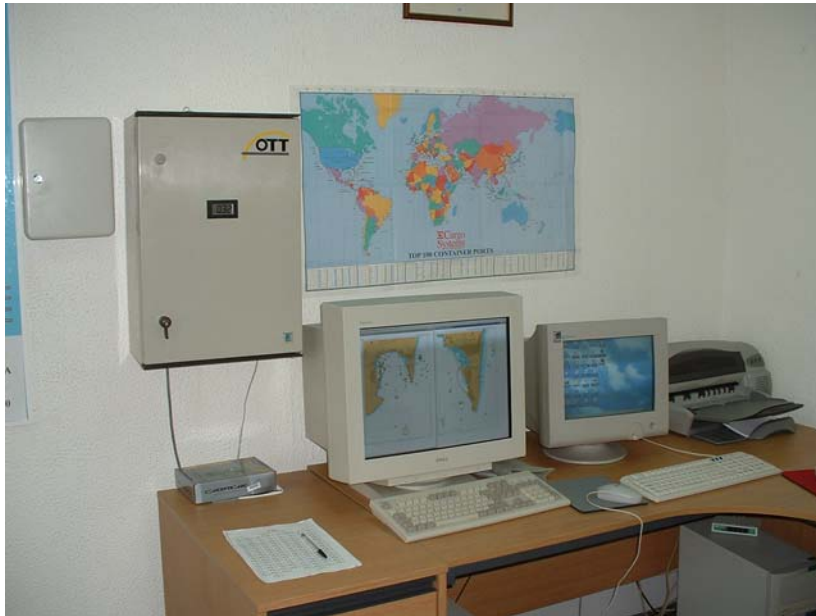
Data logging system in the Port Office

A cabinet containing the data logger, power control unit, back-up battery, radio receiver and modem was mounted in the port control. The data can be accessed locally on an office PC and via the modem. The data is collected weekly by the British Oceanographic Data Centre, BODC at POL where it is quality checked and data banked. A second POL system collects data every hour and displays it on the POL web site.

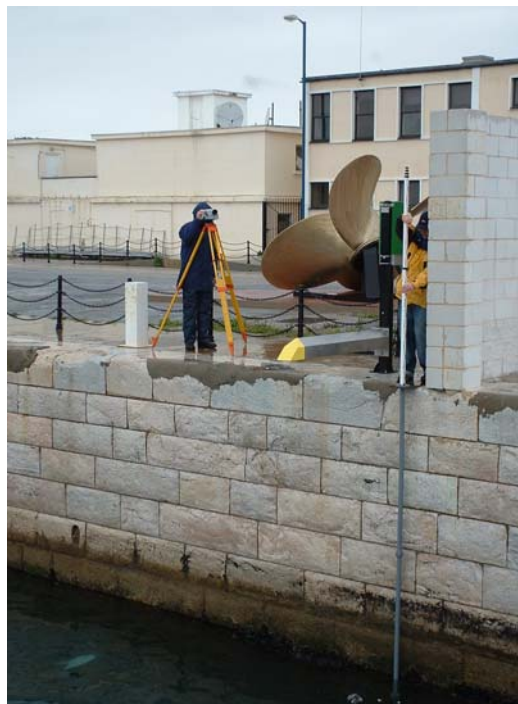
Levelling of stilling well

Another visit was made in September 2005 to maintain the tide gauge system and complete the levelling. All bench marks were levelled between the TGBM (RN) and the TGBM (CP). The recorded data was verified by a Van de Castele test. A steel plate was fixed on the quay edge and a mini stilling well was mounted to it. The top of the stilling well was levelled to the TGBM. (CP) An acoustic sensor attached to a tape measure was used to dip the stilling well at 5 minute interval and the results were compared with the recorded data. On completion it was not necessary to adjust the tide gauge datum.

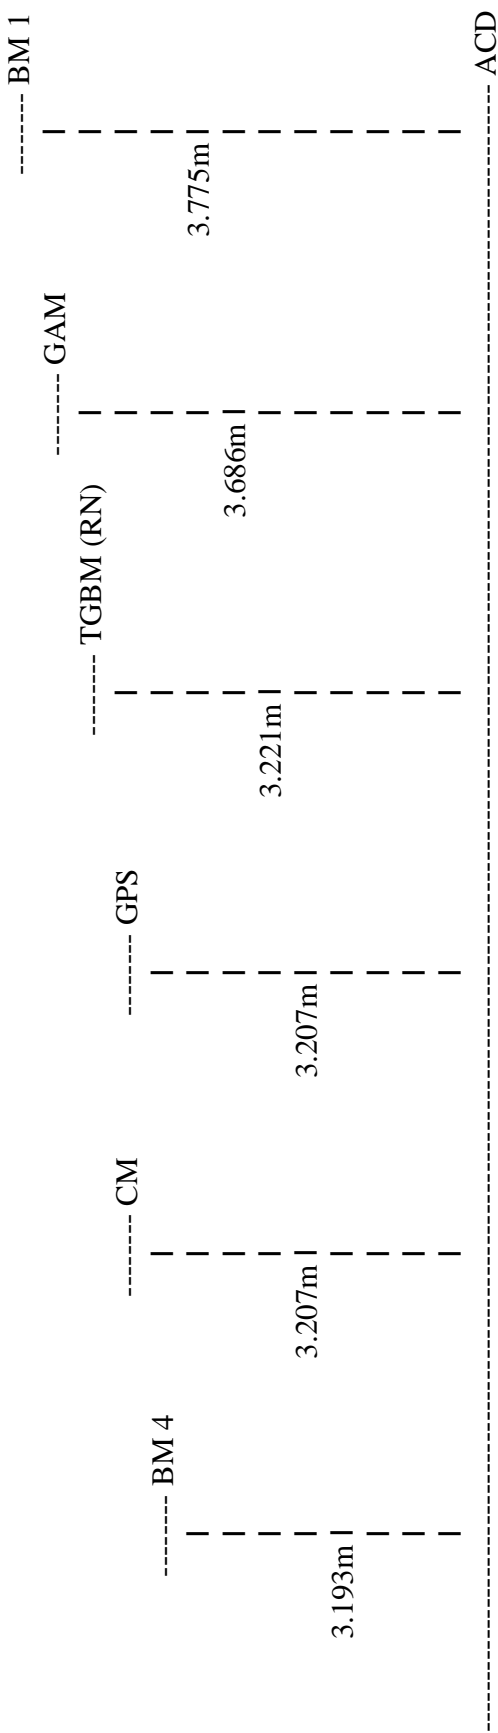
Bench marks within the RN Base

• TGBM(RN)	Tide Gauge Bench Mark	Brass bolt on coping stone W of GPS marker.	3.221m
• BM 1	Naval Stores	Flush bracket 10962 NE face of building.	3.775m
• BM 4	Bench Mark	Rivet on coping stone N of TG building.	3.193m
• CM	Contact Mark	Rim of stilling well.	3.207m
• GAM	German Altitude Marker	Horizontal bolt in pillar E of TG building.	2.686m
• GPS	Global Positioning System	Large iron GPS marker 13.78m NW of TG building.	3.207m
• ACD	Admiralty Chart Datum

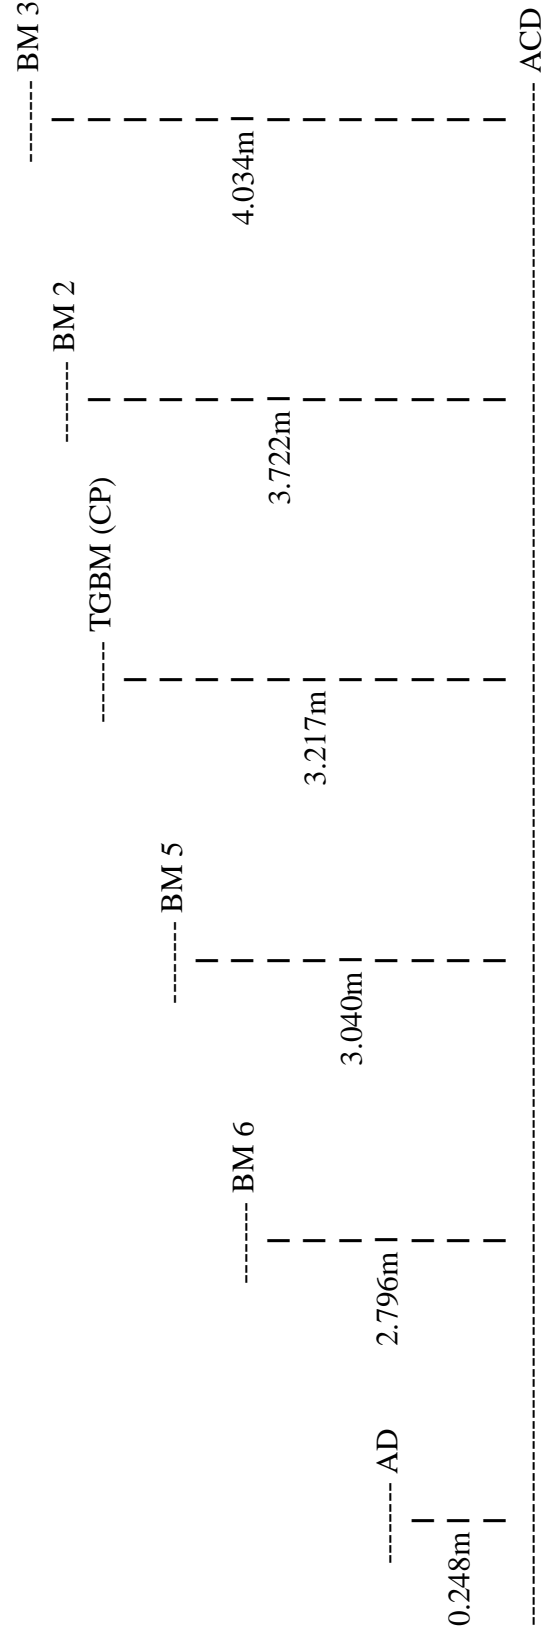
• TGBM (CP)	Tide Gauge Bench Mark	Brass bolt on quay edge W of tide gauge.	3.217m
• BM 2	Jumpers Bastion	Cut mark SW face of wall.	3.722m
• BM 3	Ragged Staff Gates	Cut nark SW face 60m S of gates	4.050m
• BM 5	Kings Bastion	Metal stud recessed into wall 0.5m above pavement.	3.040m
• BM 6	Chatham Counterguard	Cut mark SW corner S face	2.796m
• AD	Alicante Datum		0.248m
• ACD	Admiralty Chart Datum		0.000m

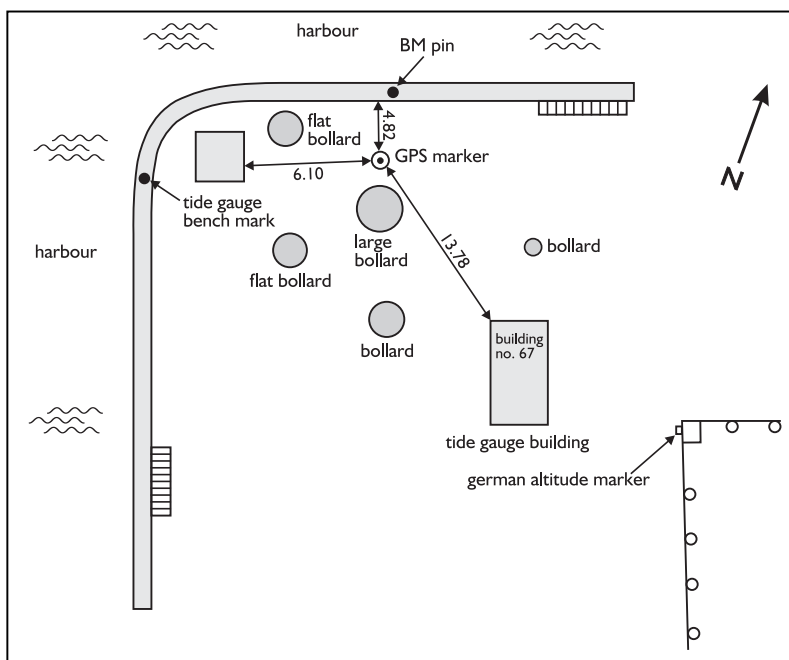
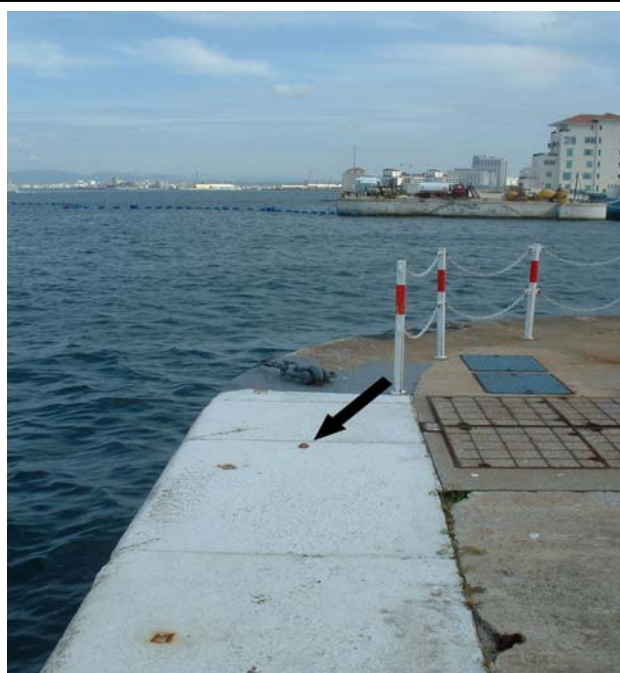
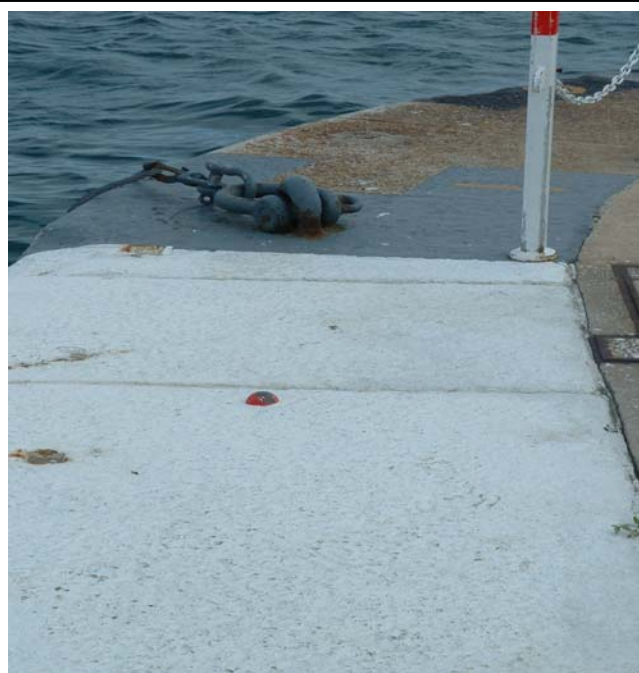
Tide Gauge Bench Mark (TGBM RN), Royal Naval Base

Bolt on quay coping W of tide gauge building.

In older documents this mark is referred to as BM4, Bolt AP and the British altitude marker. This is the Tide Gauge Bench Mark, Royal Navy (TGBM RN). A survey by HMS Herald in 1995 considered this mark to be unreliable. The Bench Mark was inspected in 2005 and was in good condition.

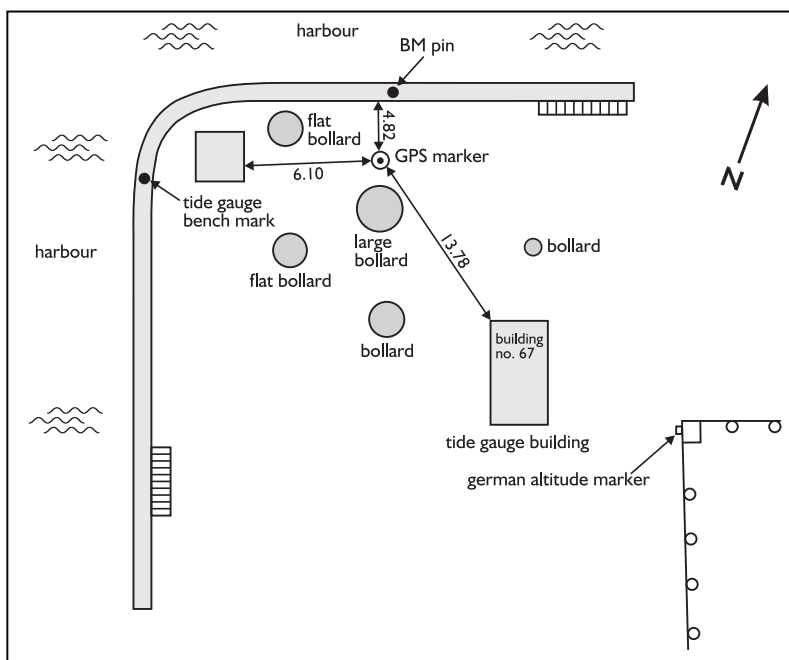
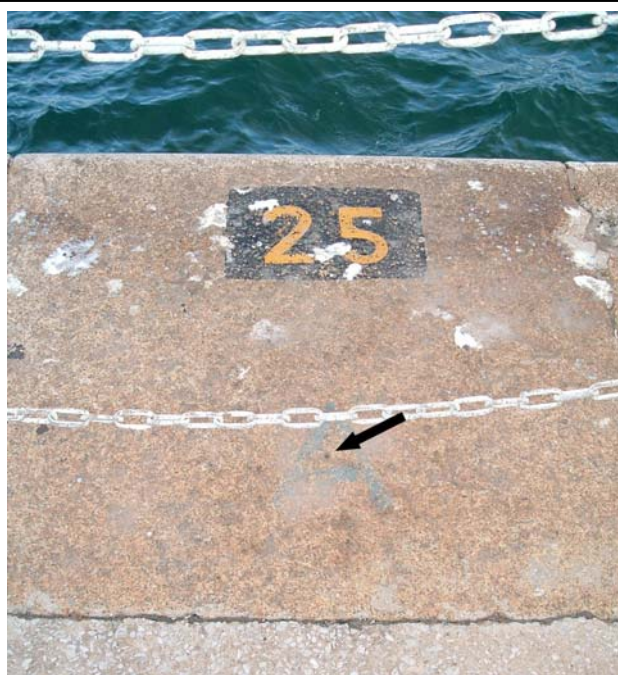
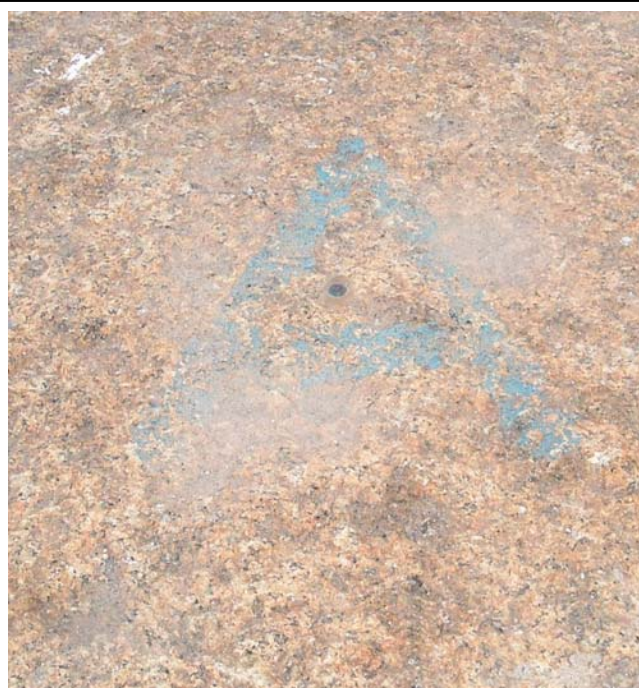
Bench Mark Pin (BM 4), Royal Naval Base

A steel pin on the quay coping stone N of GPS marker.

The Bench Mark is in good condition but it is small pin only 4mm diameter. This mark is also listed in previous documents as BM PSA 1984.

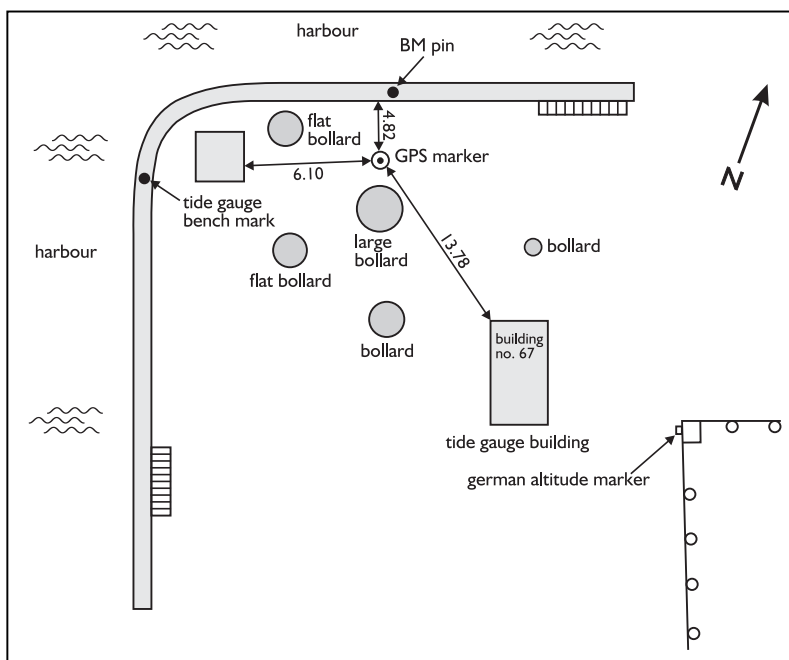
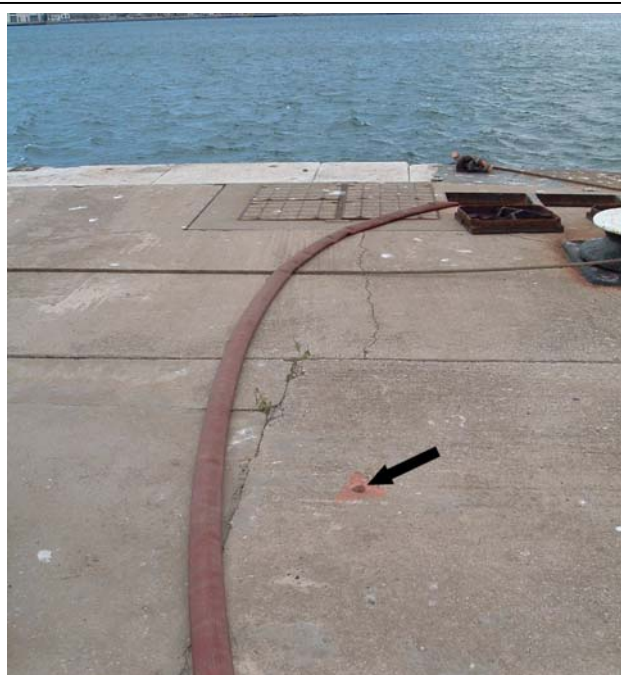
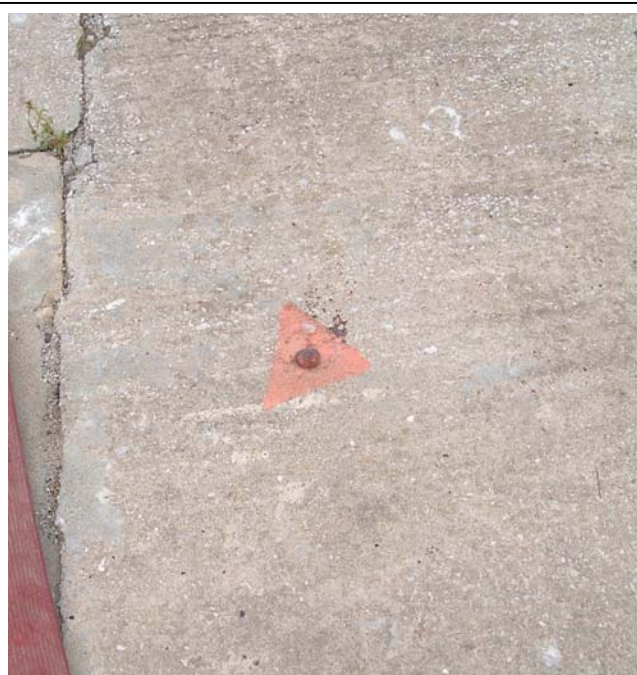
GPS Marker, Royal Naval Base

An Iron bolt NW of tide gauge building.

The Bench mark is in good condition.

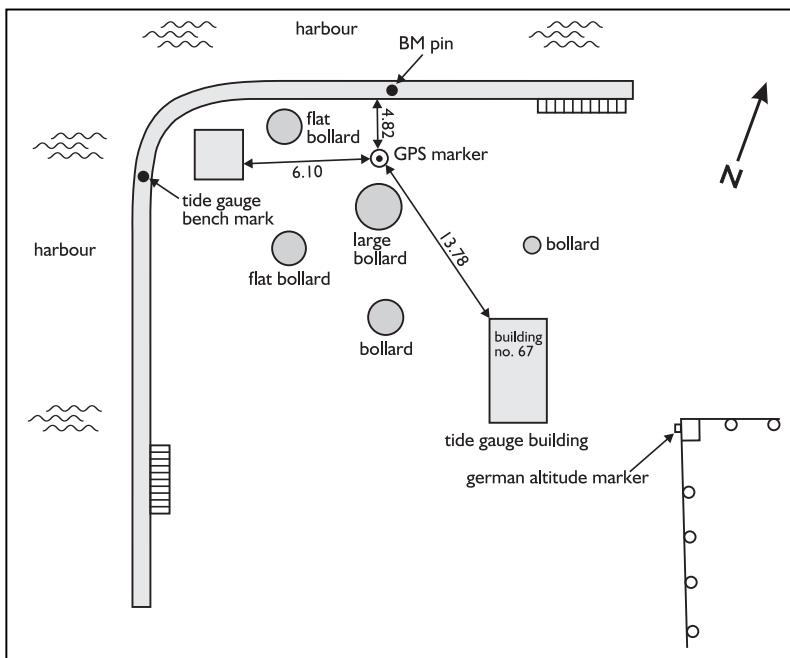
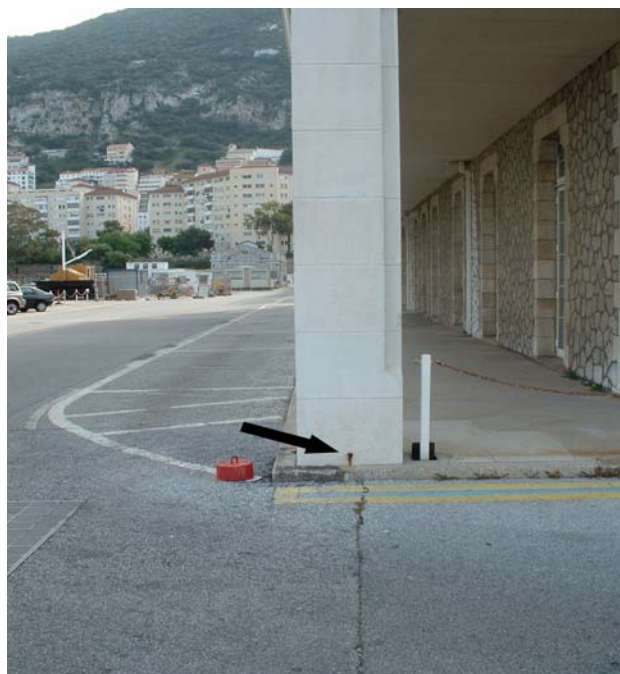
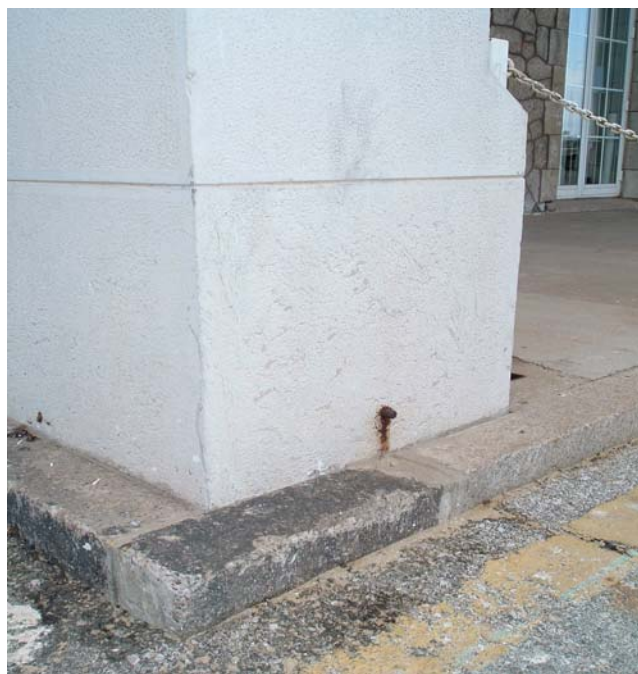
German Altitude Marker, Royal Naval Base

A horizontal steel pin in the pillar at the NW corner, W face of RN HQ.

The Bench Mark shows signs of corrosion.

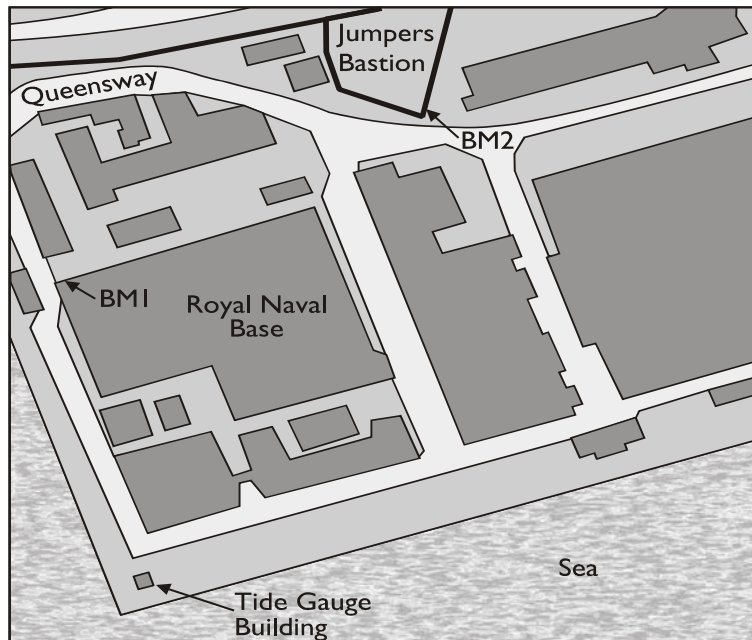
Naval Stores (BM 1), Royal Naval Base

An Ordnance Survey bracket at the NE corner E face of stores building.

The photograph below shows the tide gauge building in the distance.

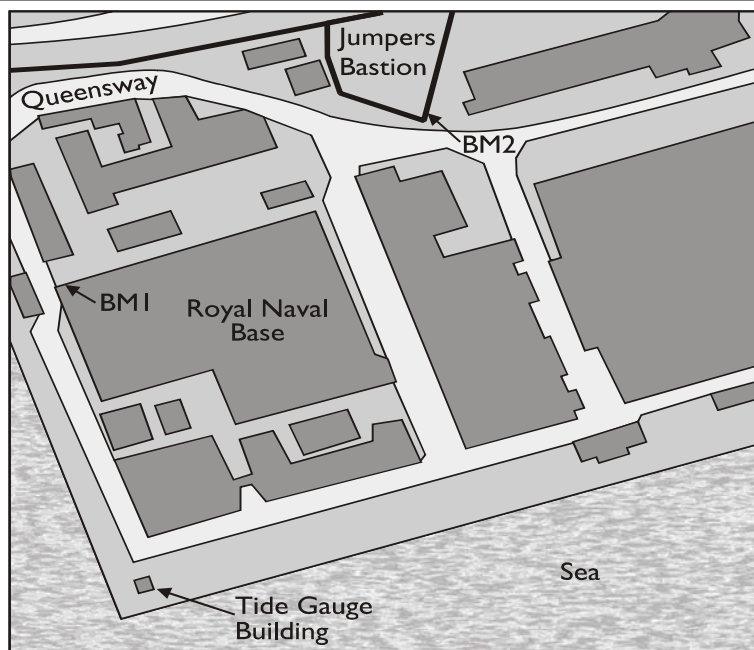
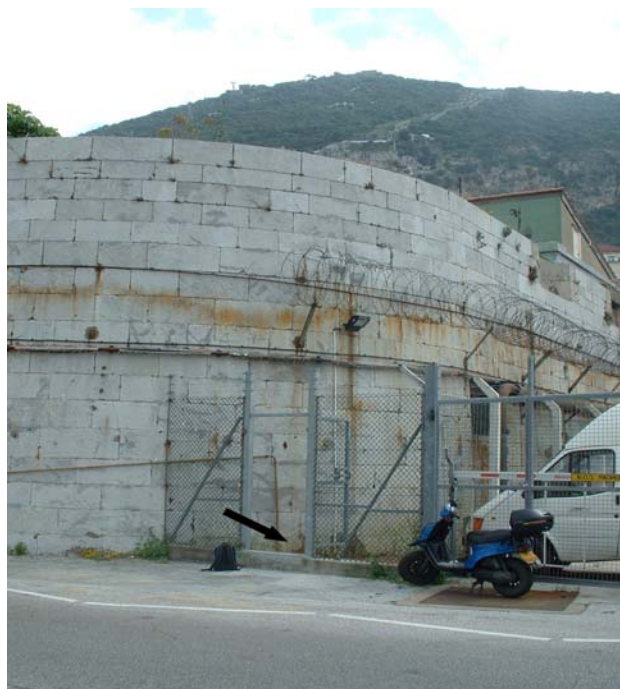
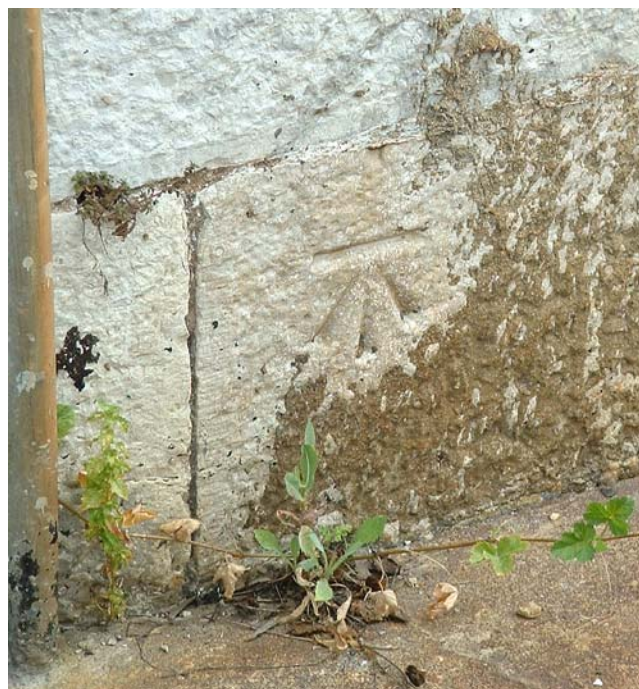
Jumper Bastion (BM 2)

An Ordnance Survey cut mark on the SW face of Jumpers Bastion 30cm above ground.

The Bench Mark is in good condition.

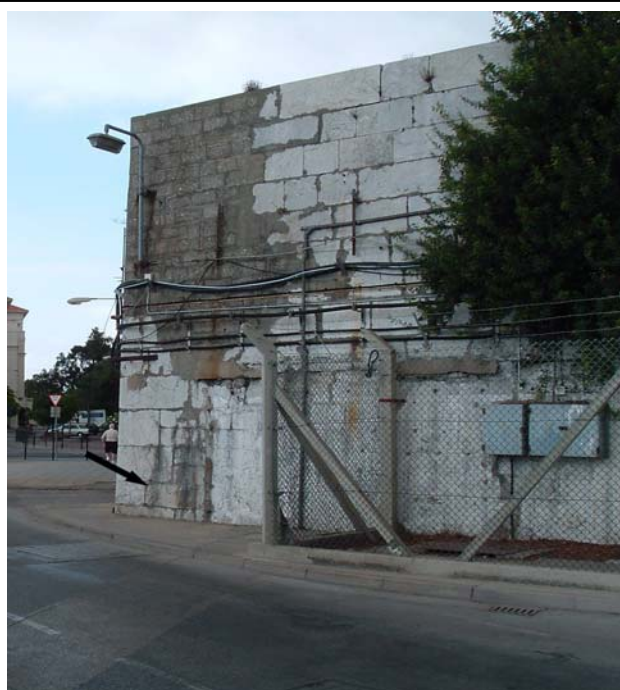
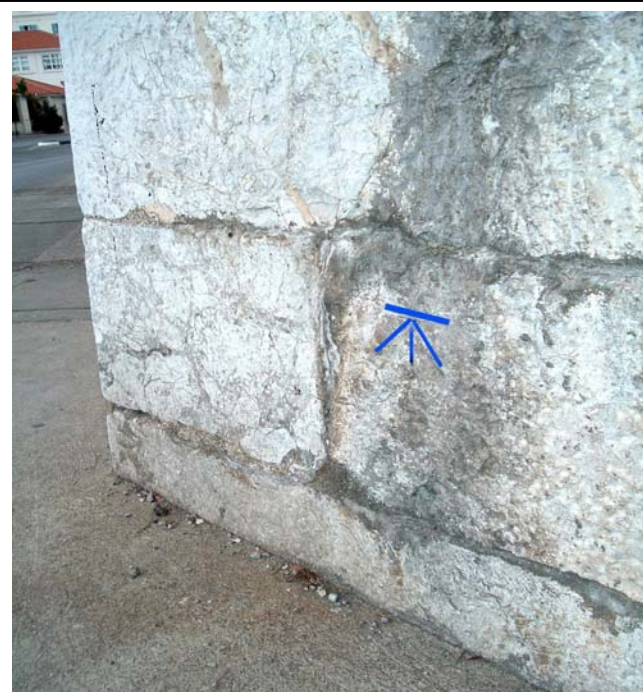
Ragged Staff Gates (BM 3)

An Ordnance Survey cut mark 30cm above ground. It is 2m SE from the W corner of the city walls and is 60m S of Ragged Staff Gates.

The Bench Mark is in good condition but difficult to see.

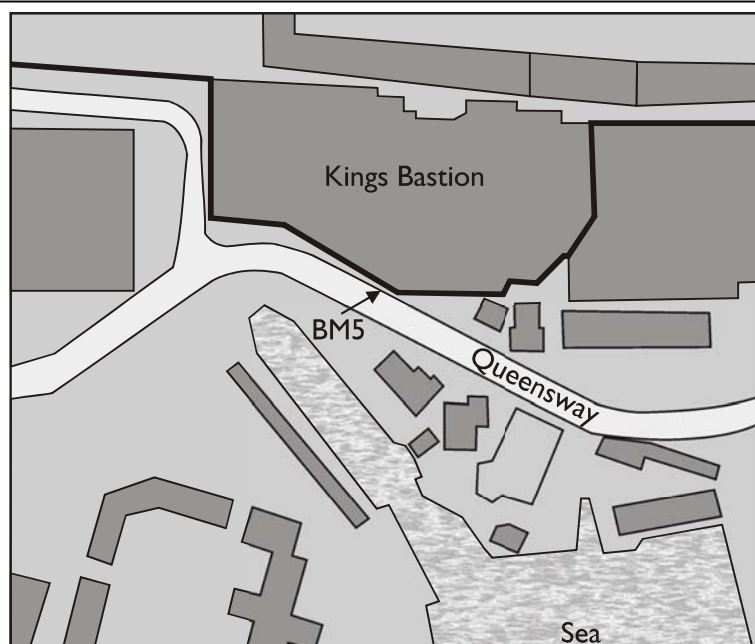
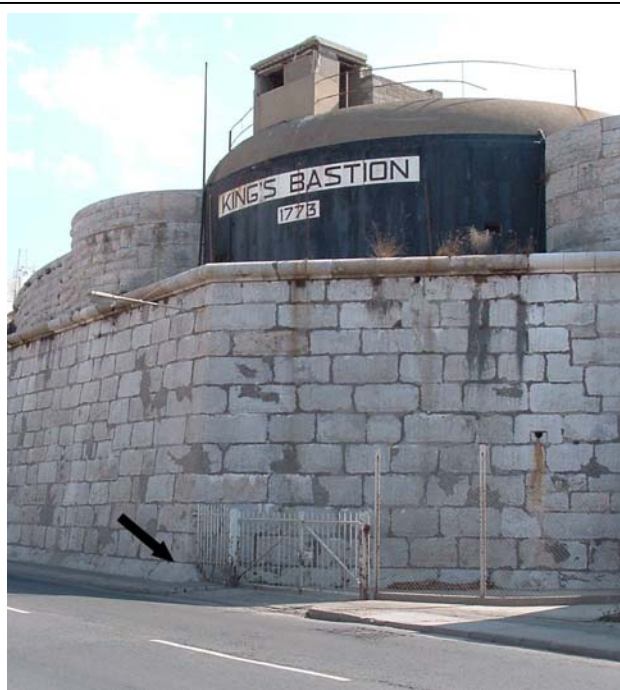
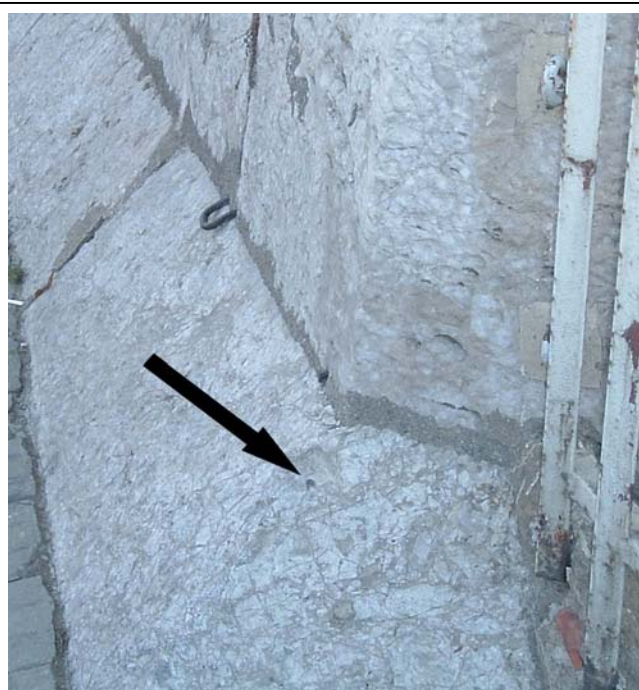
Kings Bastion (BM 5)

A domed pin at the W corner recessed into wall.

The stonework around the Bench Mark is damaged and may be lost. The leg of the staple nearest to the BM (shown on the right hand photograph) was also levelled.

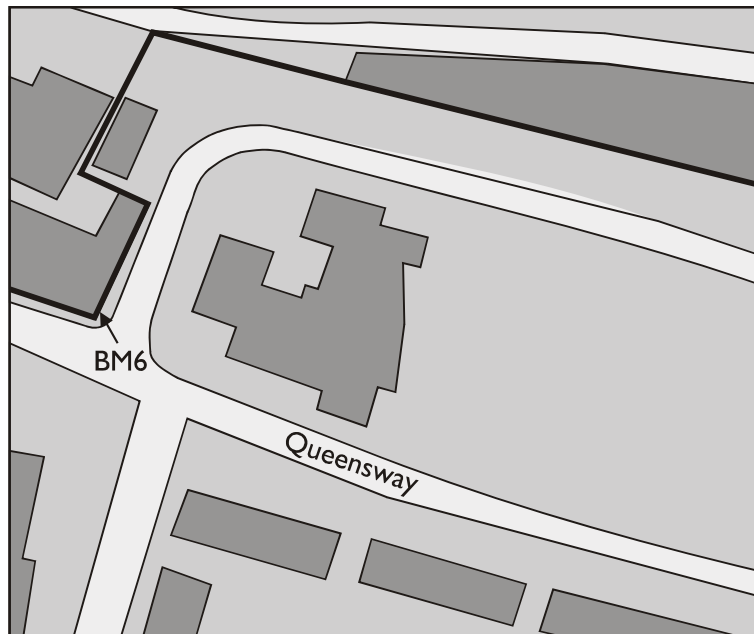
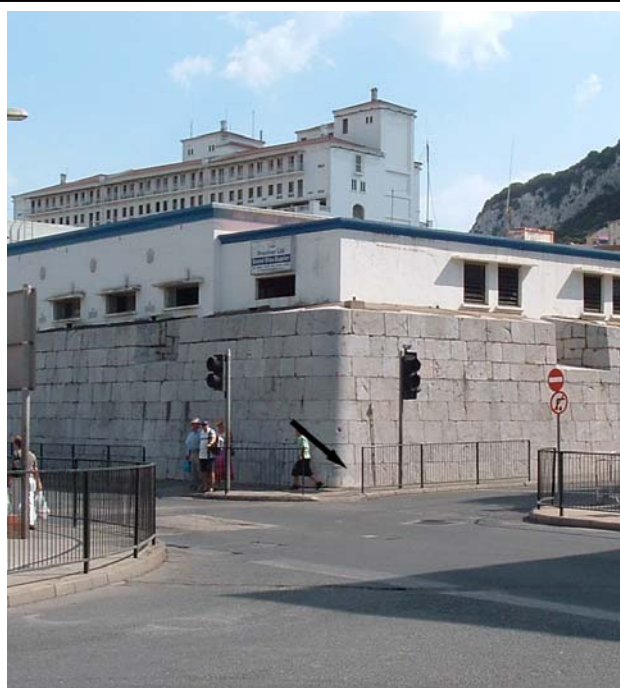
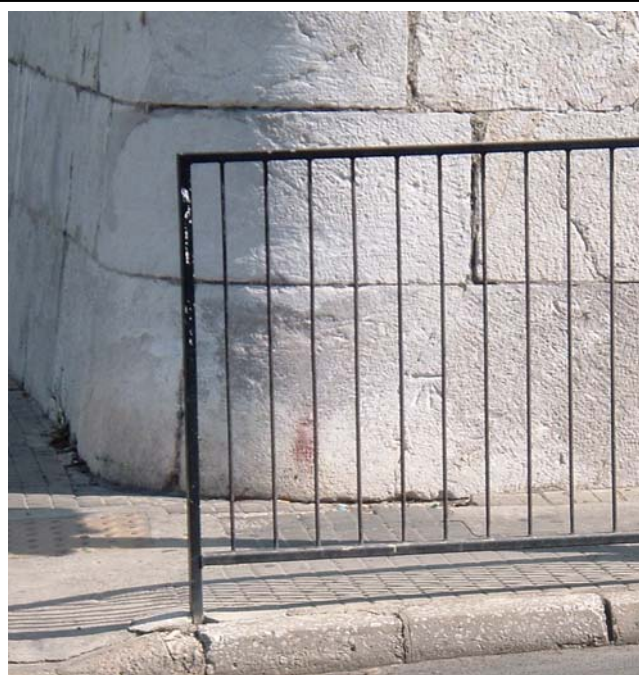
Chatham Counterguard (BM 6)

An Ordnance Survey cut mark at the SW corner on the S face 25cm above ground

The Bench Mark is in good condition. This bench mark has not been used in previously levelling.

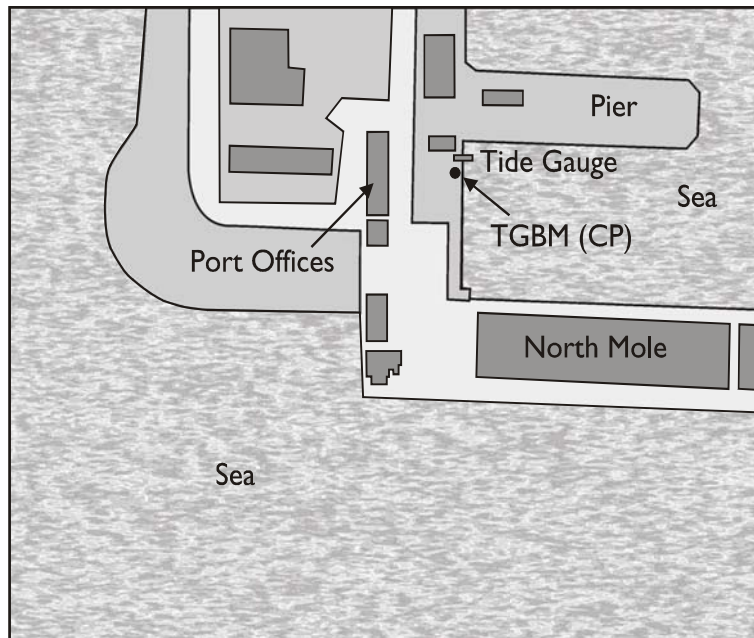
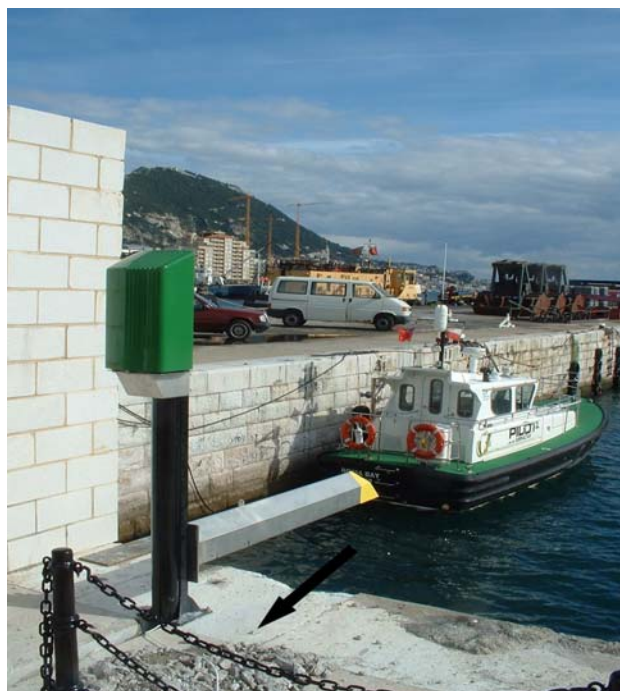
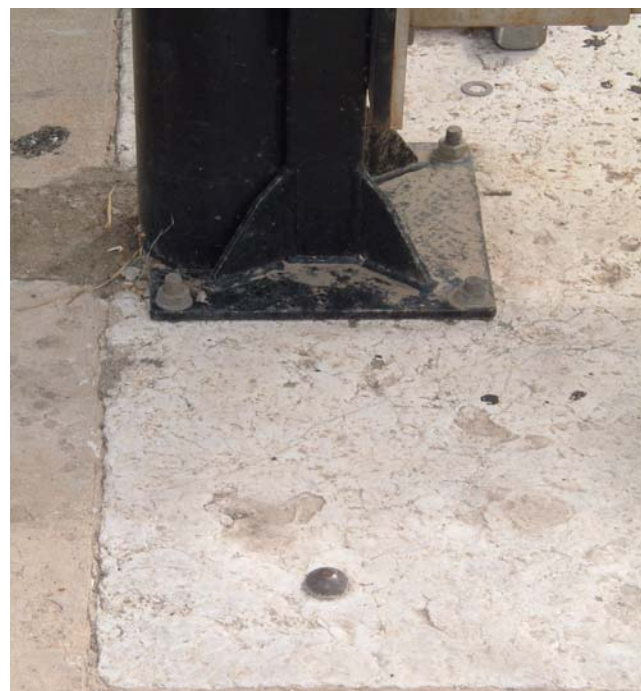
Tide Gauge Bench Mark (TGBM CP) Port Authority

Brass bolt on the quay coping 1m W of the tide gauge.

This is a new Bench Mark installed in 2004.
