**Gibraltar Harbour
Site Survey and Installation
Of a Radar Tide Gauge**

July 2006

Proudman Oceanographic Laboratory

Internal Document No. 179

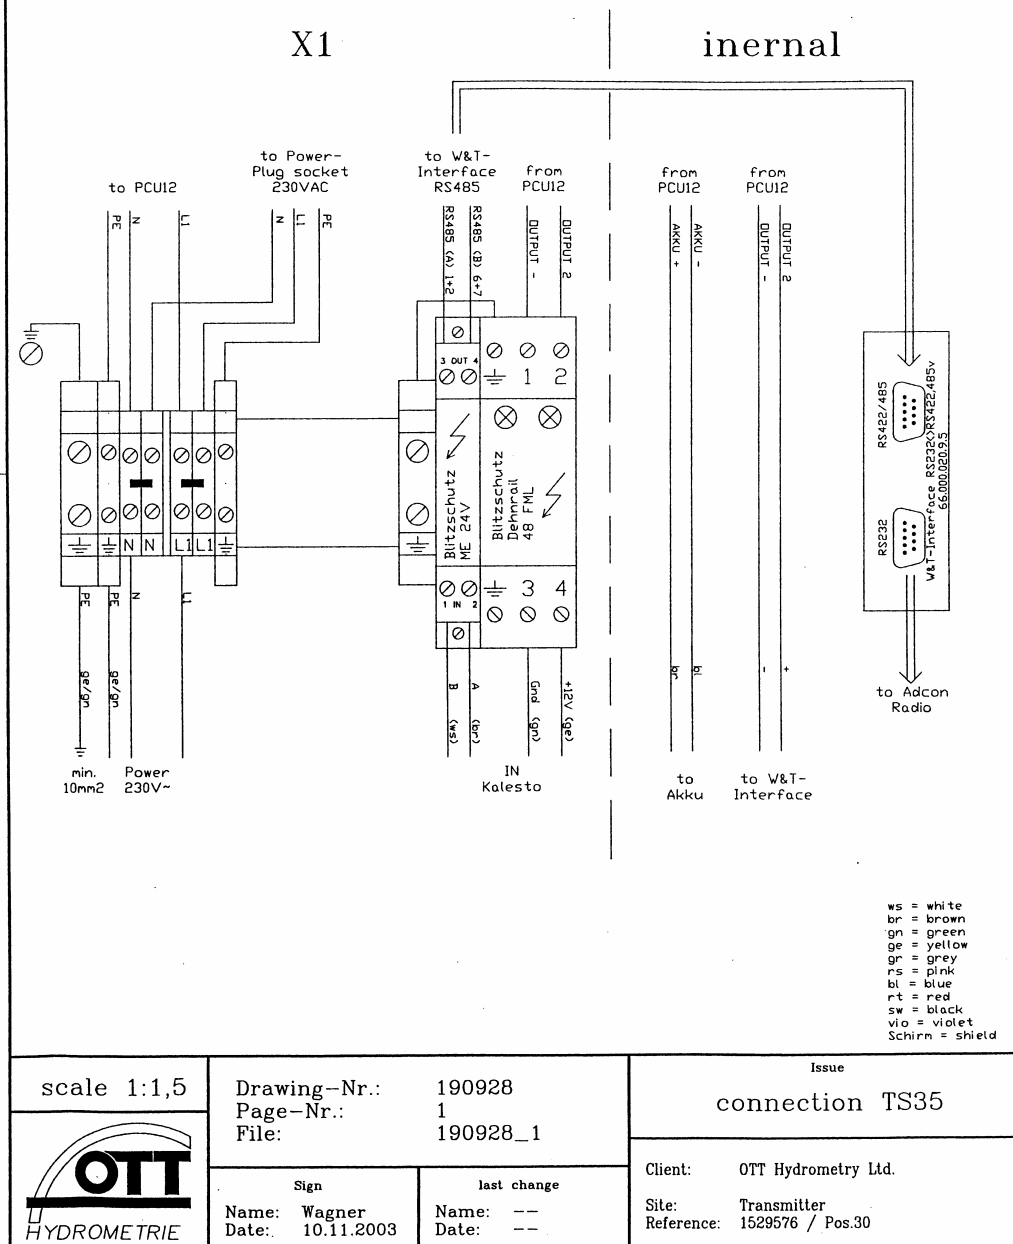
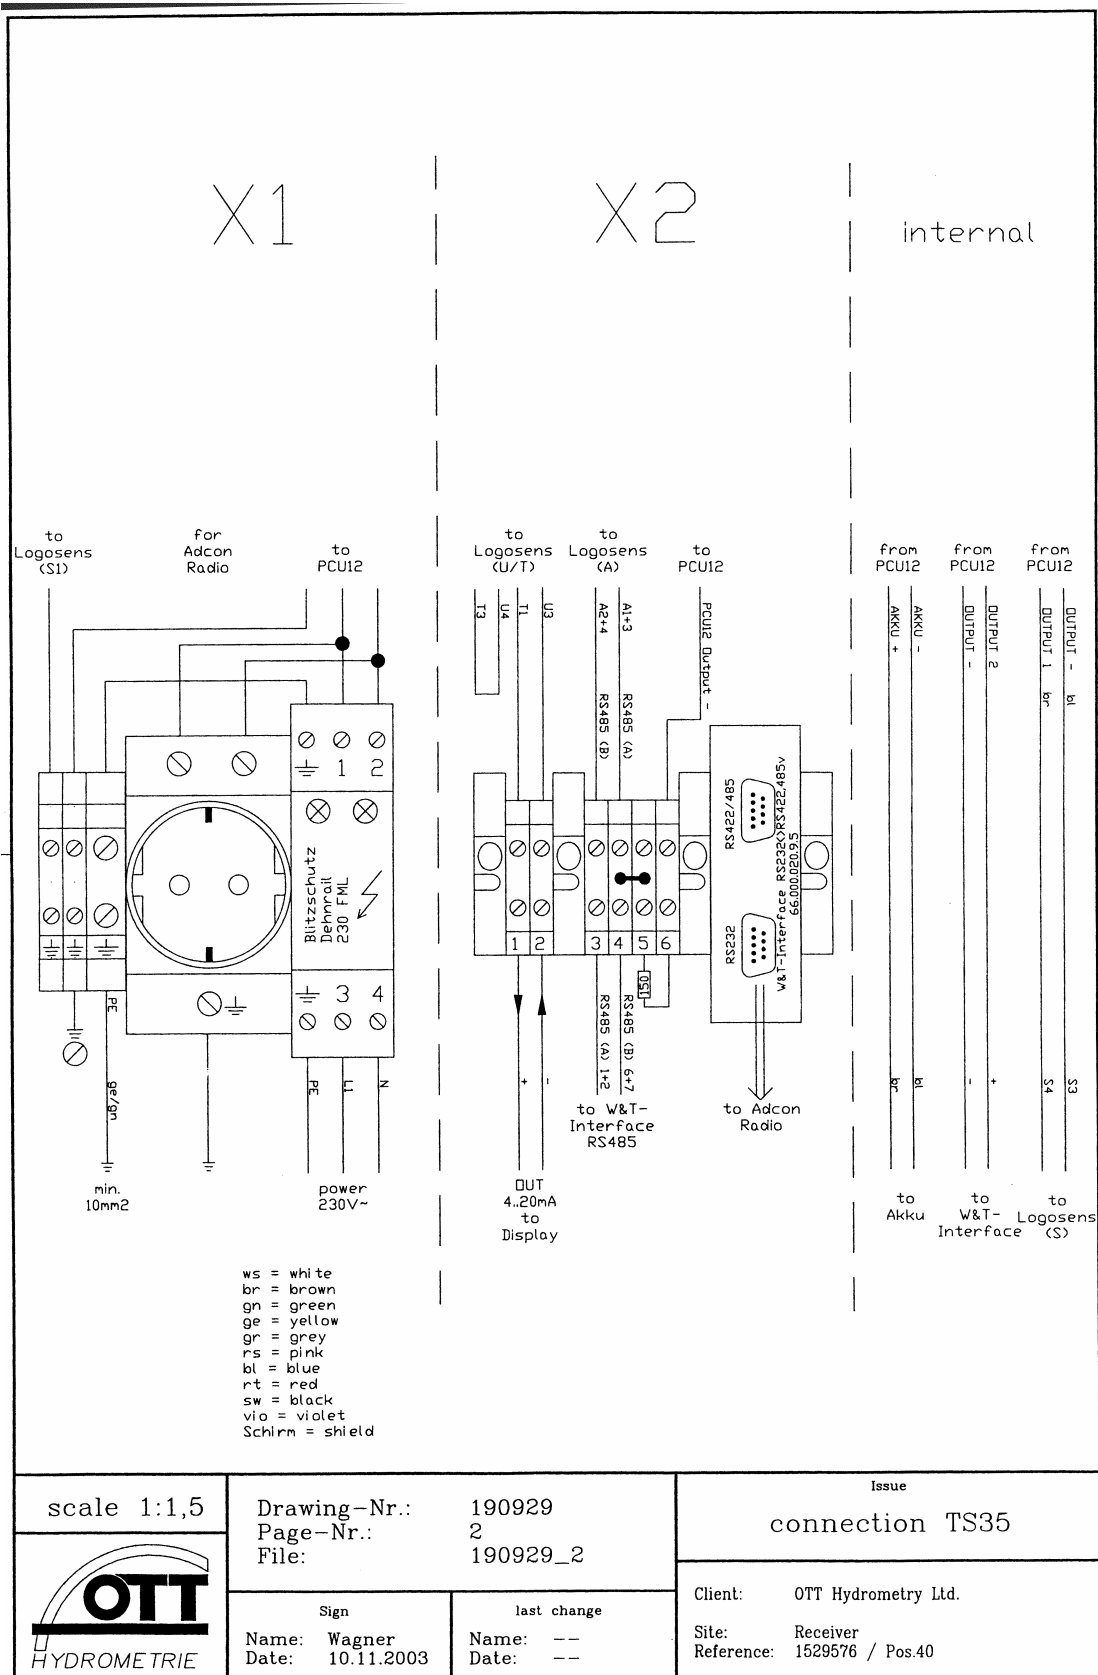
Compactstation Transmitter

Circuit diagrams of the transmitter and receiver are shown in Annex B.
